# Manhole Inspection Summary

Manhole # S31AA1001MH

**Location** Address: **SAN MARTIN DR**

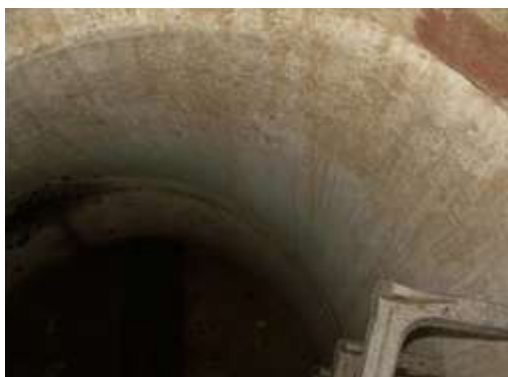
Defect

Infiltration: ☐ None ☒ **Joint** ☐ Cracks ☐ Mortar ☐ Roots ☐ Wall

Infiltration: ☐ None ☒ **Joint** ☐ Cracks ☐ Mortar ☐ Roots ☒ **Wall**

Corbel and Barrel infiltration.

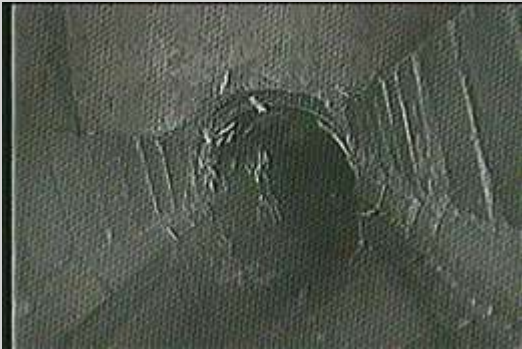
### 8 in. Circular Gravity Sewer Pipe Out @ 12 O'Clock

Infiltration: **Evidence** Pipe Seal Cond: **Unknown**

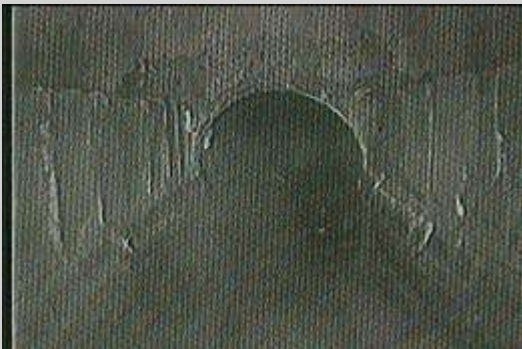
### 8 in. Circular Gravity Sewer Pipe In @ 6 O'Clock

Infiltration: **None** Pipe Seal Cond: **Unknown**
